North Ninth Gateway
Salinas, Kansas

project	North Ninth Gateway
client	City of Salinas
design	Vicki Scuri/Siteworks, Public Artist
electrical planning	Wilson & Company
photographer	Jeff Cooper Photography

Corral - Diffuse column and bollard
with protective rings

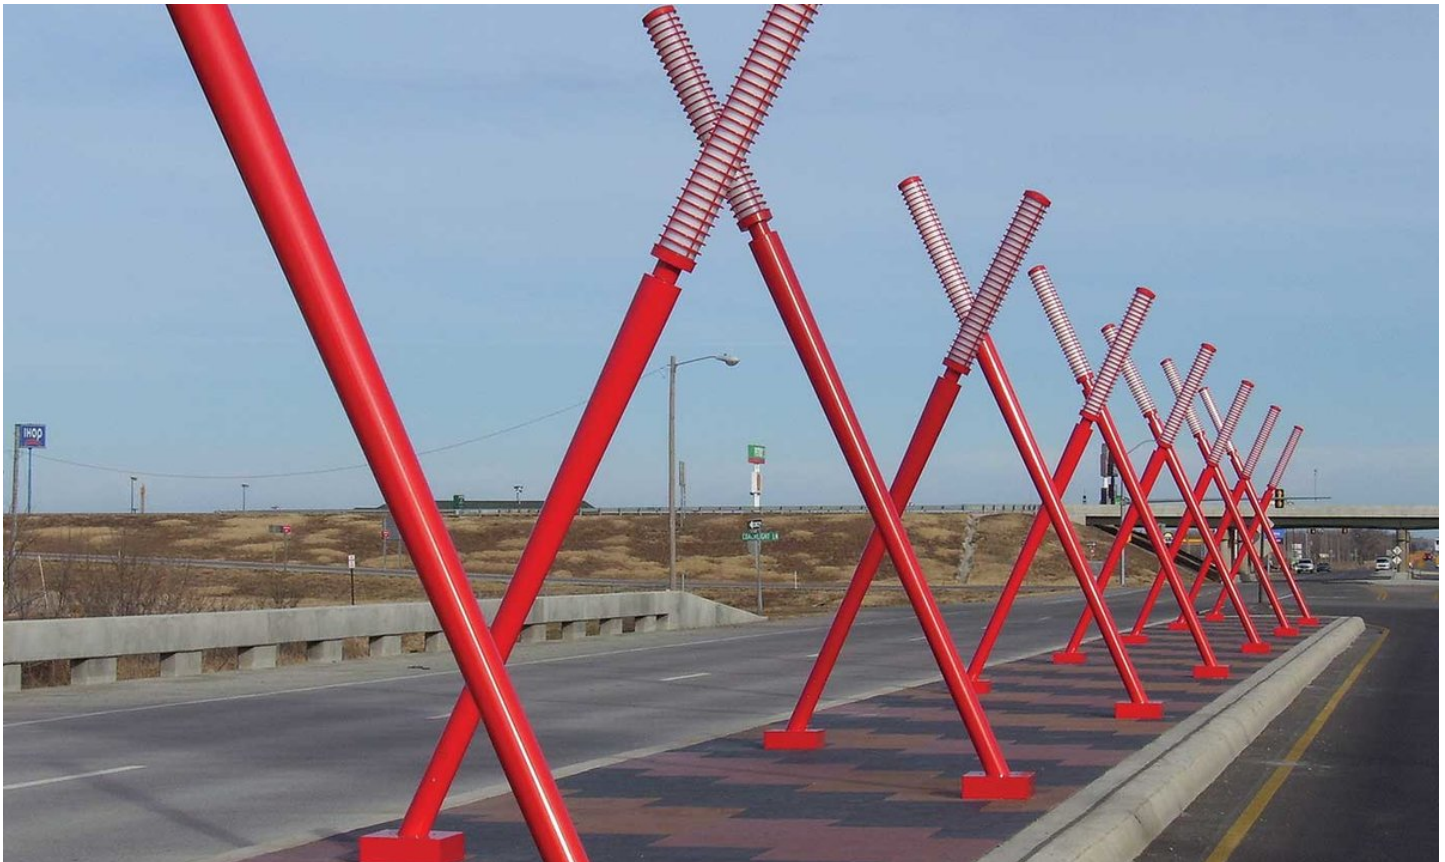
This project involved the retrofit of an existing bridge; replacing the median and adding 15 colorful Selux Corral Columns (“light sticks”) that are angled at 65 degrees. The eye-catching angled pole design of the Corral Columns crisscross activating the “railroad patterned” brick median creating a graphic sculptural symbol that is visible for some distance. The artwork also highlights the small creek that crosses the interstate which is often overlooked due to all the trucks, stops, and motels along the interstate.

Selux Corral Columns create a unique, engaging form that activates the median with uniform lighting. The columns were chosen for their sleek design, durability, and ability to integrate architectural forms and landscapes.

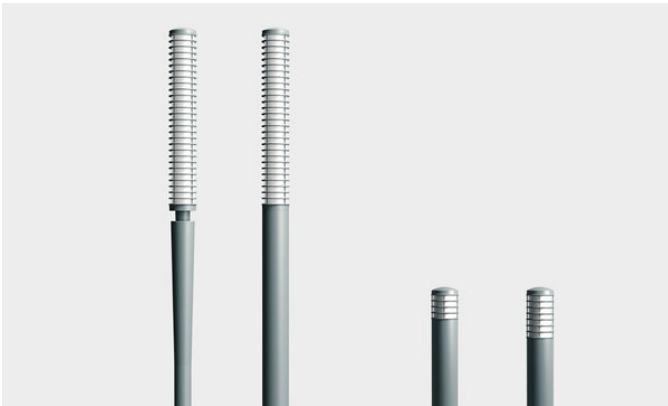
Corral® by Selux is a diffuse family of luminaires consisting of columns and bollards. The protective Corral® rings around the diffuse polycarbonate shielding add a decorative feature, and can be selected in a variety of lit section heights. For columns, choose from a straight or tapered pole with an overall height up to 16 feet.

Construction	Die cast low-copper aluminum · Extruded straight or reverse tapered column
Optic	White, translucent acrylic · UV-stablized
Light Source	LED in 2700K, 3000K, 3500K, 4000K · 90CRI minimum
Light Distribution	Type IV · Type V
Dimensions	Ø8" · Light module 2', 3', or 4' · Overall height from 10' through 16'
Finish	Tiger Drylac certified polyester powder coat finish
Options	GFCI · 0-10V dimming · HiLo Switching · Motion Sensor with optional Photocell
Certificates	NRTL Wet Location · 5 Year LED Warranty · RoHS Compliant · Union Made - IBEW Local 363 · ASTM and PCI for finish · IK10
[en:]	Exterior
[en:]	Corral

Construction	Die cast and extruded low-copper aluminum · Stainless steel fasteners
Optic	White, translucent acrylic · UV-stablized
Light Source	LED in 2700K, 3000K, 3500K, or 4000K · 90CRI minimum
Light Distribution	Type IV · Type V
Dimensions	Ø8" · Overall bollard height 1 1/2' through 4'
Finish	Tiger Drylac certified polyester powder coat finish
Options	GFCI · 0-10V dimming · HiLo Switching
Certificates	NRTL Wet Location · 5 Year LED Warranty · RoHS Compliant · Union Made - IBEW Local 363 · ASTM and PCI for finish · IK10
[en:]	Interior - Exterior
[en:]	M36 - Hei by Selux
